# Manhole Inspection Summary

Manhole # S15M\_\_006MH

Insp Date: **3/11/08 1:24 PM**

**Location** Address: **334 tyrone st**

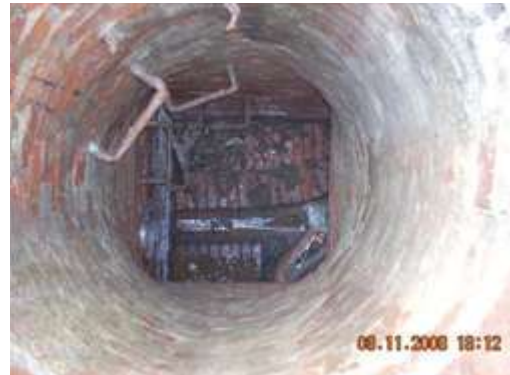
Top View

12 oclock is under shelf

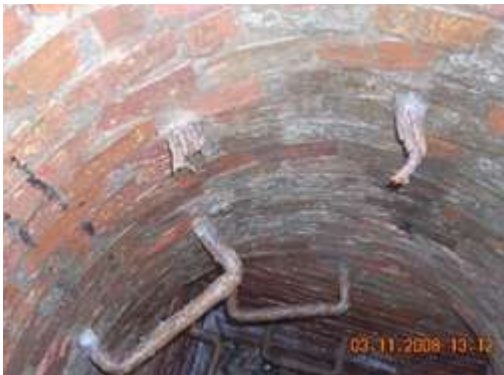
Defect 2

Count: **5** Missing: **1** ☒ **Corroded**

corroded and missing steps

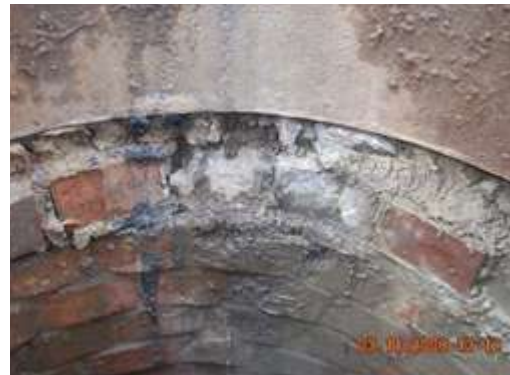
Defect 1

Condition: ☐ Sound ☐ Cracked ☐ Root Intrusion ☐ Loose Brick ☒ **Deteriorated**

deteriorated chimney

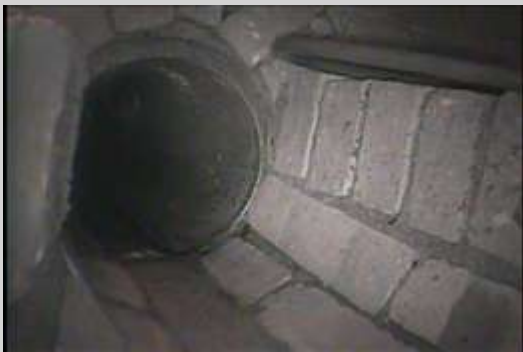
12 O'Clock Outflow

located under shelf

Pipe Height: **8.4** (in.) Rod and Bar (Angled)  
Pipe Material: **Clay** ☐ Pipe Lined  
Invert Depth: **11.24** (ft.) Flow Characteristics: **Slow**  
Deposits: ☒ None ☐ Mud ☐ Sludge ☐ Debris ☐ Grease  
Silt Depth: **0** (in.) Deposits Extent:  
Infiltration: **None** Pipe Seal Cond: **Sound**

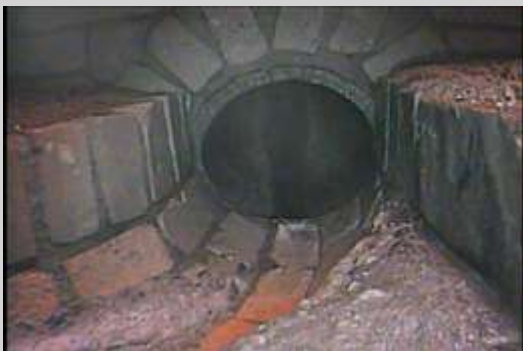
6 O'Clock Inflow

Pipe Height: **8.4** (in.) Rod and Bar (Angled)  
Pipe Material: **Clay** ☐ Pipe Lined  
Invert Depth: **7.66** (ft.) Flow Characteristics: **Slow**  
Deposits: ☒ None ☐ Mud ☐ Sludge ☐ Debris ☐ Grease  
Silt Depth: **0** (in.) Deposits Extent:  
Infiltration: **None** Pipe Seal Cond: **Sound**

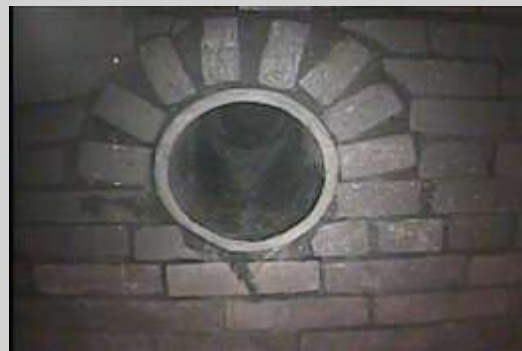
Drop In @ 6 O'Clock

Drop: **Outside** Rod and Bar  
Angled: **Yes** Reading: **10.02** (ft.)  
Inv Depth: **11.02** (ft.)  
Drop Condition: **Open**

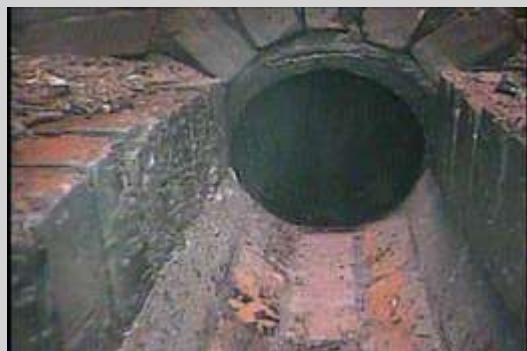
9 O'Clock Inflow

Pipe Height: **8.4** (in.) Rod and Bar (Angled)

Pipe Material: **Clay** ☐ Pipe Lined

Invert Depth: **7.07** (ft.) Flow Characteristics: **Slow**

Infiltration: **None** Pipe Seal Cond: **Sound**

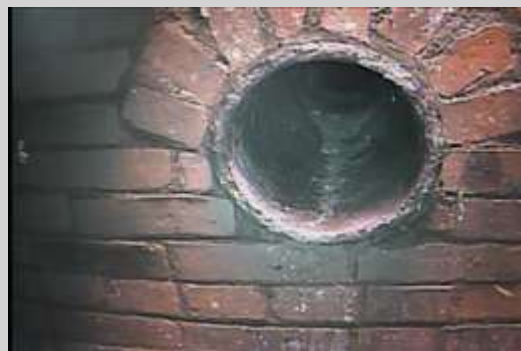
Drop In @ 9 O'Clock

Drop: **Outside** Rod and Bar

Angled: **Yes** Reading: **9.46** (ft.)

Inv Depth: **10.46** (ft.)

Drop Condition: **Open**
